Manhole Inspection Summary

Manhole # S29Q__012MH

Location Address: **611 Ridgley St**

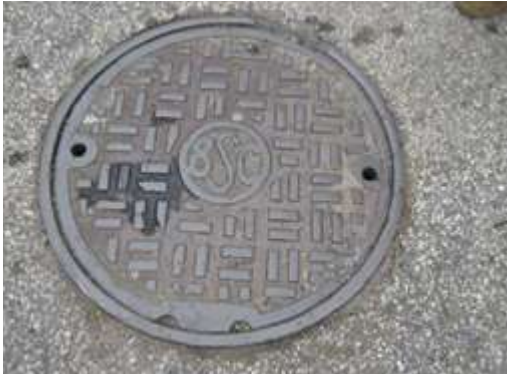
mh cover

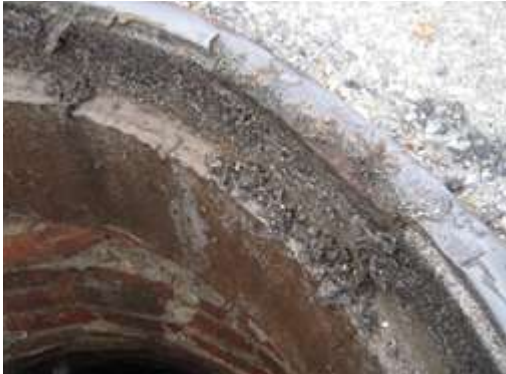
Defect 6

Condition: ☐ Sound ☒ **Cracked** ☐ Leaks

Damaged frame

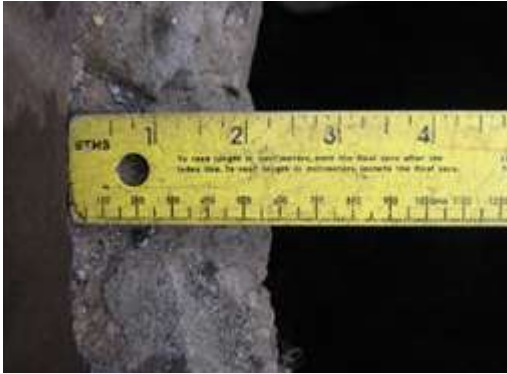
Defect 5

Offset: **2** (in.)

Frame offset 2"

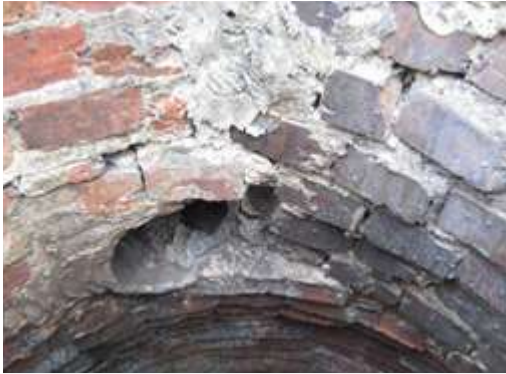
Defect 4

Condition: ☐ Sound ☒ **Cracked** ☐ Root Intrusion ☒ **Loose Brick** ☒ **Deteriorated**

Chimney Loose bricks and mortar

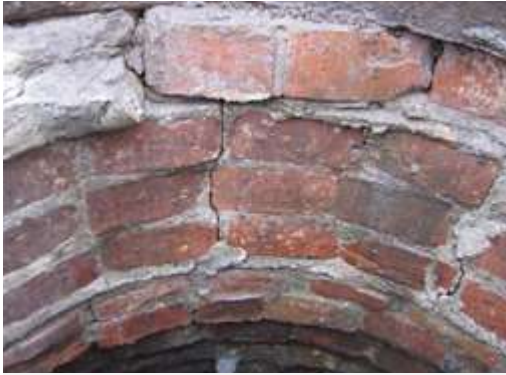
Defect 3

cracked corbel

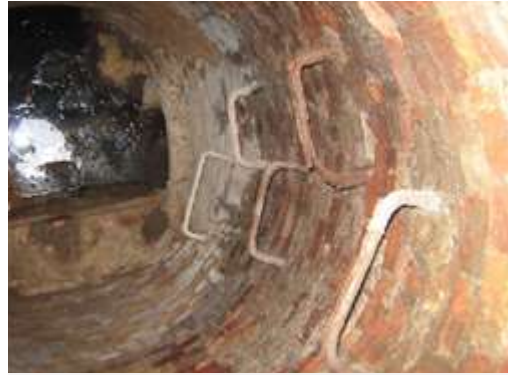
Defect 2

Count: **5** Missing: **0** ☒ **Corroded**

Corroded rungs; infiltration along entire wall

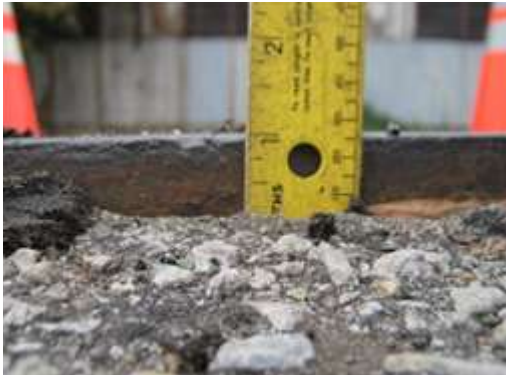
Defect 1

above grade

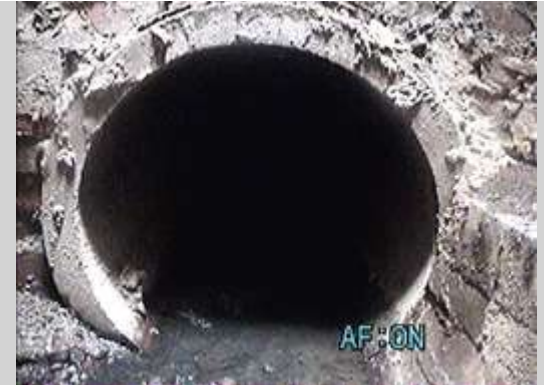
12 O'Clock Outflow

Pipe Height: **20.4** (in.) Rod and Bar (Angled)
Pipe Material: **Clay** ☐ Pipe Lined
Invert Depth: **10.30** (ft.) Flow Characteristics: **Slow**
Deposits: ☐ None ☐ Mud ☒ **Sludge** ☐ Debris ☐ Grease
Silt Depth: **2** (in.) Deposits Extent: **Light**
Infiltration: **None** Pipe Seal Cond: **Sound**

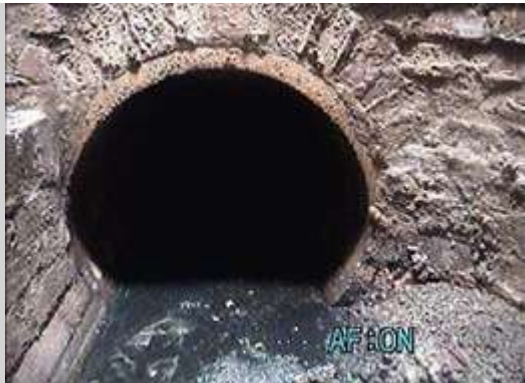
9 O'Clock Inflow

Deposits: ☐ None ☐ Mud ☒ ~~Sludge~~ ☐ Debris ☐ Grease

Silt Depth: **2** (in.) Deposits Extent: **Light**
